ARCHITECTS ACCREDITED

AABC

Application Guidance Notes

How to apply for AABC accreditation

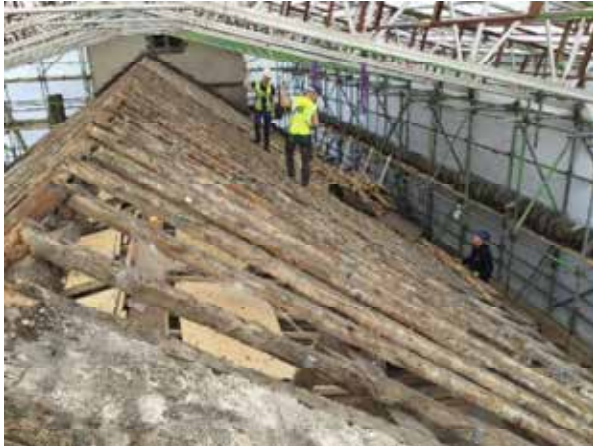
Slates being carefully removed and stacked in order, any replacement slates were slotted in at the appropriate place to ensure slates that were remaining went back in their original position

Following completion of scaffold erection and protection works slates were carefully removed course by course as they were to go back in the same place. The scaffolding had been designed to allow for the loading. Approximately 30% of new slates were required and the new ones were swapped in as the roof stripping progressed to ensure all retained slates went back in their original position.

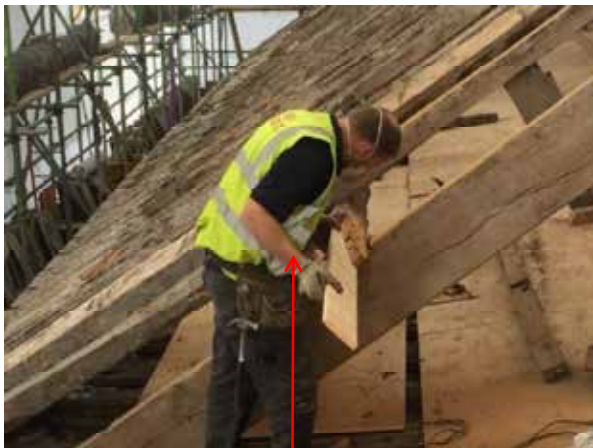
Joiner Andy making a template for a purlin repair

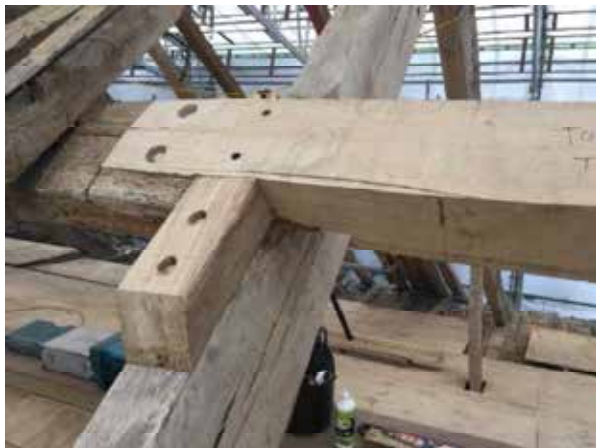
Completed purlin repair. Stainless steel fixings were used and a new oak block installed to give the purlin additional support

Roof timbers were carefully removed as necessary and the minimal impact repair interventions executed. All new structural timber was in oak to match. Only what was absolutely necessary to be removed was removed and traditional joints such as scarf joints used between pieces of timber. These repairs were authentic and this is a key conservation philosophy as mentioned in the preamble to the 1964 Venice Charter. Fixings were not all traditional and stainless steel was used to joint timbers. This was viewed as being acceptable as in many locations this additional strength of fixing was necessary to preserve more of the existing roof structure. Again this is a key consideration of article 10 of the Venice Charter. The rafter sprockets, to create the swept eaves, were cut from Douglas Fir, again to match the extant work.

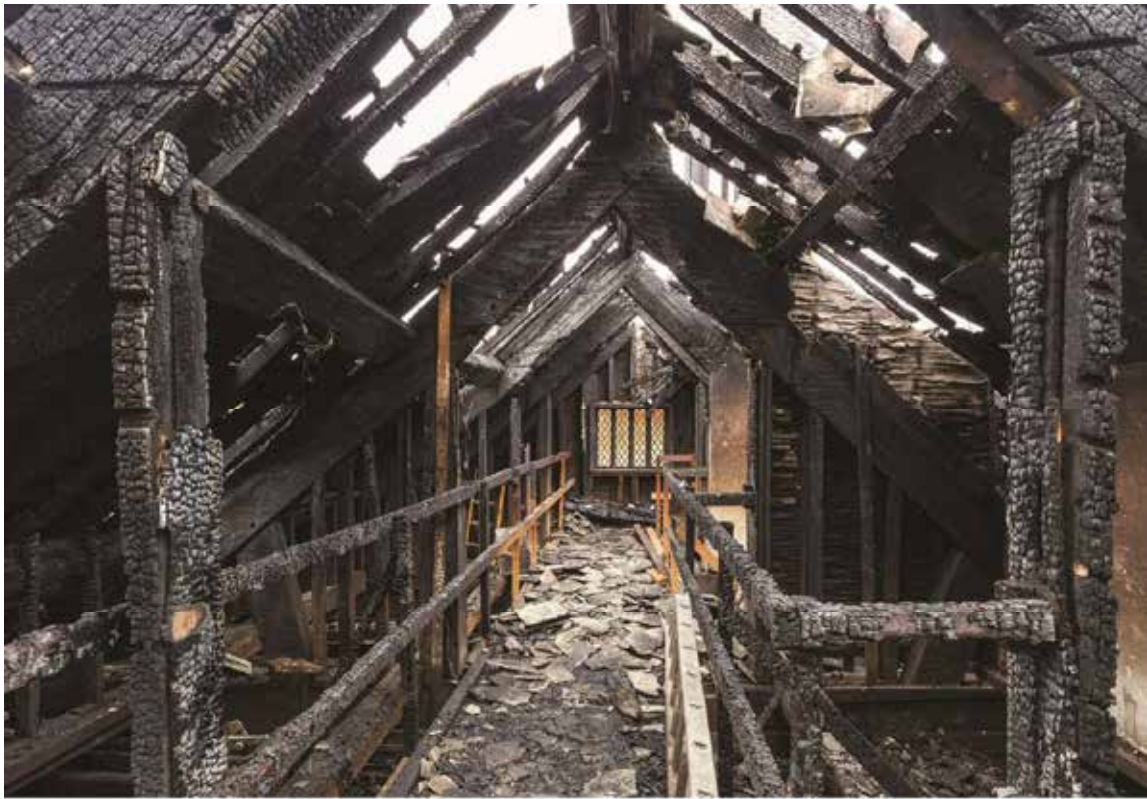
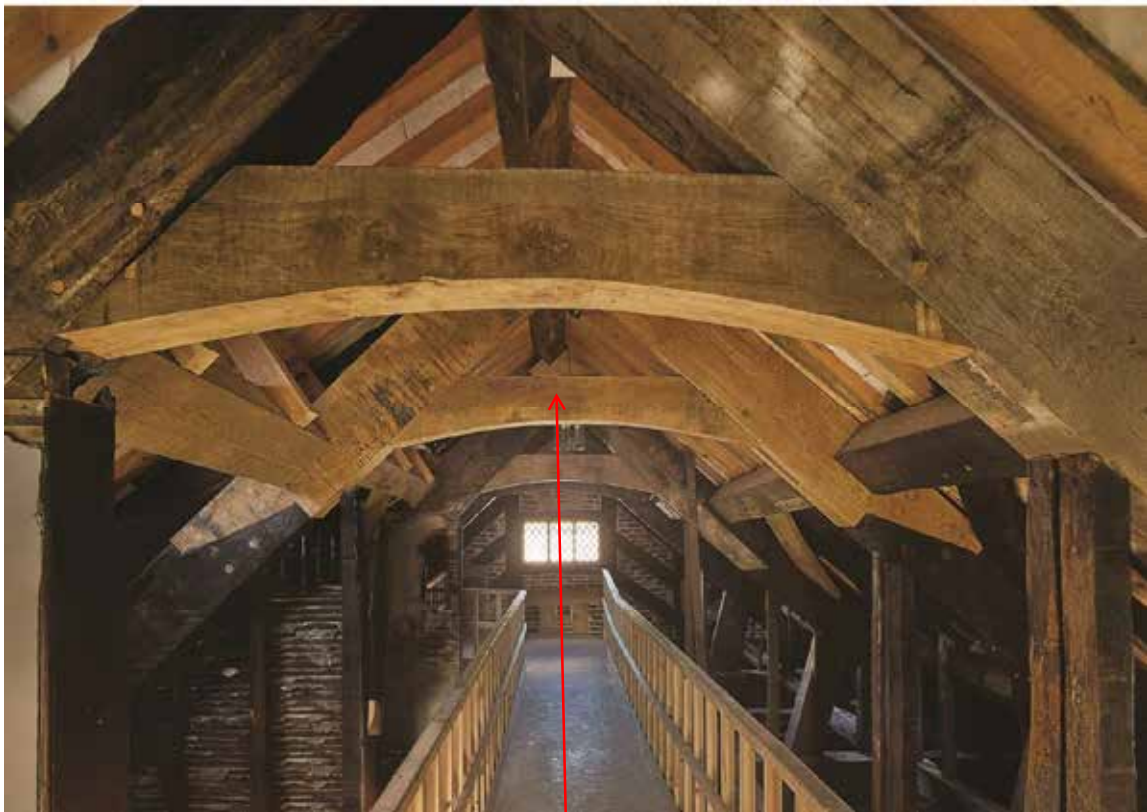
Top – The attic space immediately after the fire. The central walkway caught the debris from above, saving the plaster ceiling below.

Below – The restored attic including traditional timber repairs and rebuilt brickwork to the south gable.

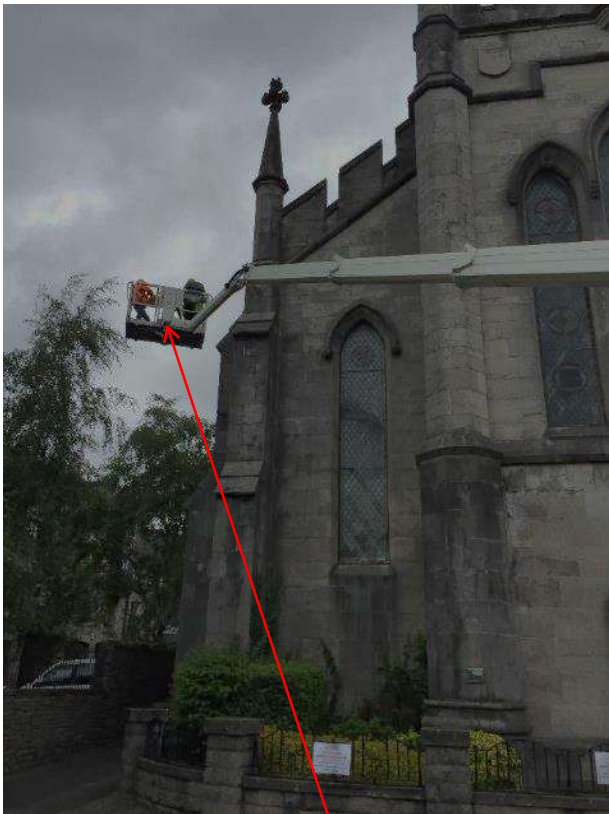
The MEWP allowed for each stone to be studied in detail

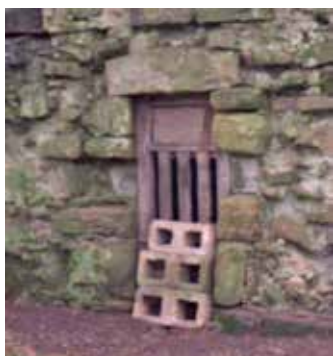
Remove window W5 and loose masonry below. Provide and fix new window cill in matching stone, finished 200mm above external ground level. Jamb up opening to receive new window. Provide and fix 2no. new 150x100 reinforced concrete lintels internally.

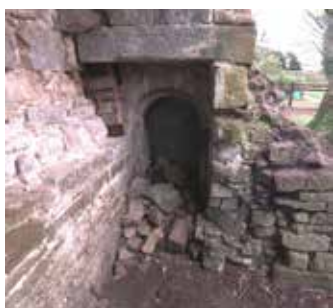
W6 to be retained as existing.

Remove timber infill (former door) W7 and one course masonry below. Provide and fix new window cill in matching stone. Jamb up opening to receive new window.

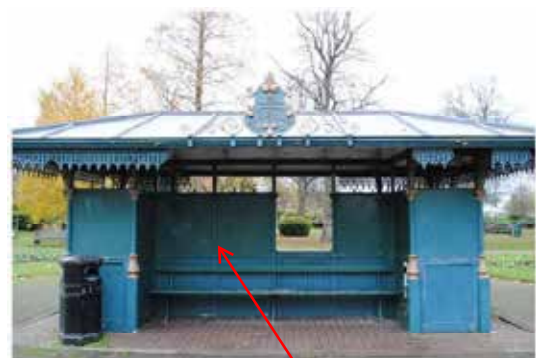
Historic details, such as the filigree to the ridge line was re-created from a mixture of looking at historic photographs and the inspection of cast iron pattern books from the period. This was then modelled on the computer by a colleague and the pattern created at the foundry by utilising the 3D computer file. Other elements, such as the barley twist balusters were created by the foundry by adapting existing patterns. Sections of the verge filigree were created by taking a mould from existing sections. All new sections were formed in ductile iron to resist vandalism as it is stronger than traditional cast iron.

Before Photograph: This helps illustrate the scope of the works.

The initial condition survey of the listed shelter indicated that whilst the structure was itself sound, it was clearly unloved. Vandalism had caused significant damage to many of the finer details. Historic photographs were used as part of the research to identify how best to present the shelter.

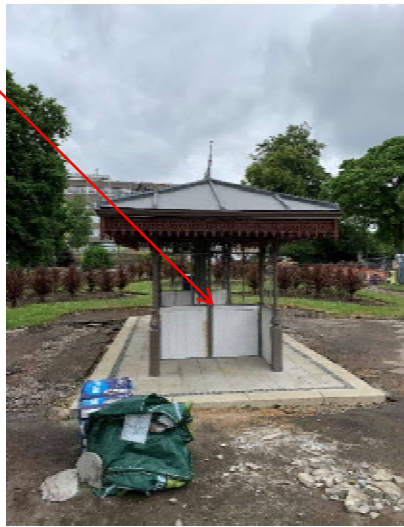
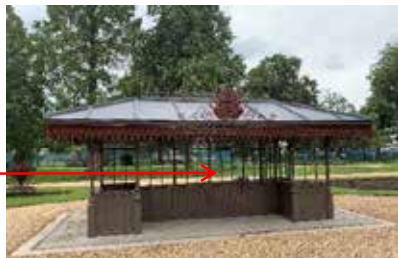
The photographs to the right show progress photos of the shelter once the new detailing had been added and timber panels inserted. The resin bound gravel to paths added to the turn of the century feel to pedestrian walkways within the park.

Progress Photos: These illustrate the works being undertaken.
